Manhole Inspection Summary

Manhole # S13C1_018MH

Insp Date: **3/5/08 10:50 AM**

Location Address: **1600 Georgetown RD (alley behind house)**

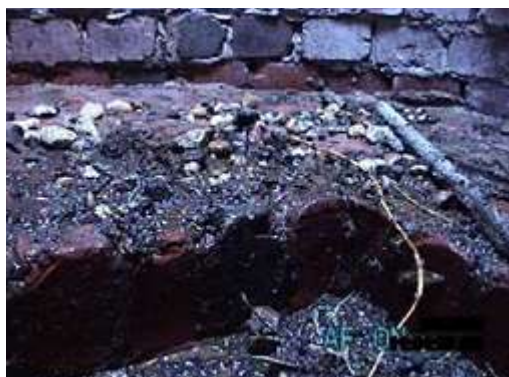
debris on bench

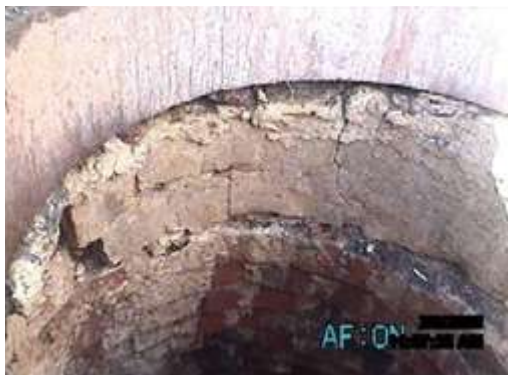
Defect 6

infiltration at 8 o'clock corbel gap
chimney-frame missing mortar/bricks and
deteriorated

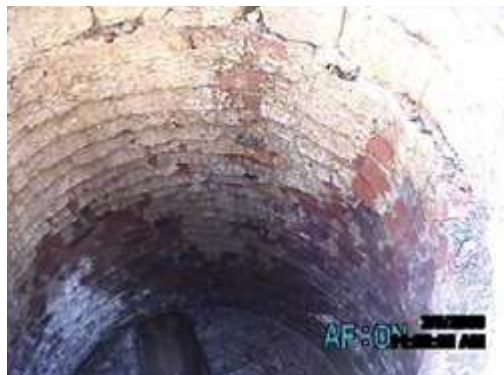
Defect 5

4 o'clock barrel infiltration active

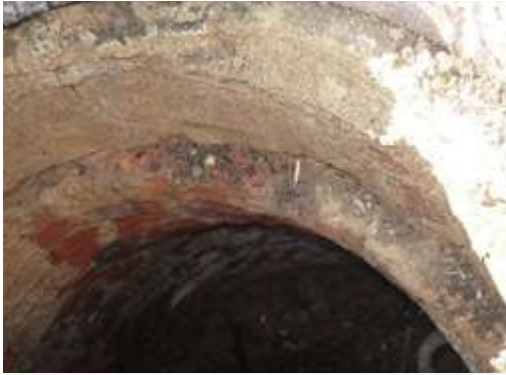
chimney-offset

signs of infiltration

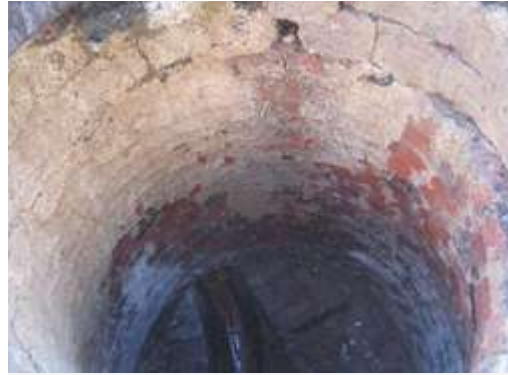
Defect 9

signs of infiltration from missing bricks as well as gap between chimney-frame

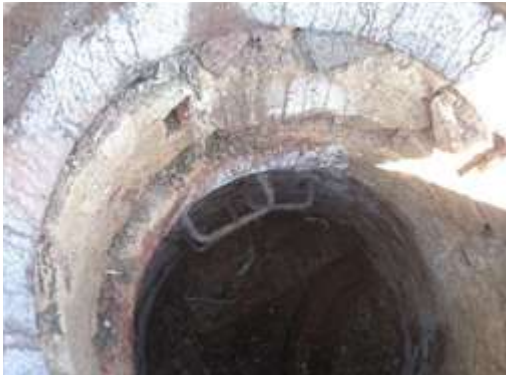
Defect 10

loose missing bricks as well as offset signs of infiltration at chimney

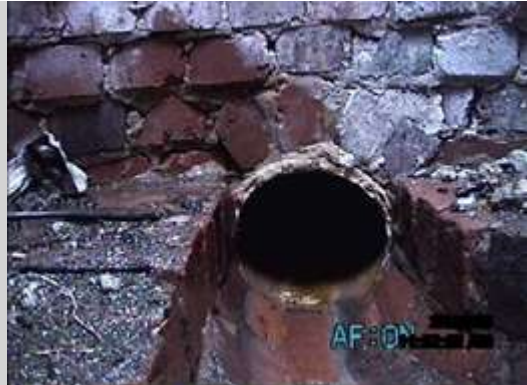
12 O'Clock Outflow

Pipe Height: **8.4** (in.) Rod and Bar (Angled)
Pipe Material: **Clay** ☐ Pipe Lined
Invert Depth: **8.28** (ft.) Flow Characteristics: **None**
Deposits: ☒ None ☐ Mud ☐ Sludge ☐ Debris ☐ Grease
Silt Depth: **0** (in.) Deposits Extent:
Infiltration: **None** Pipe Seal Cond: **Sound**

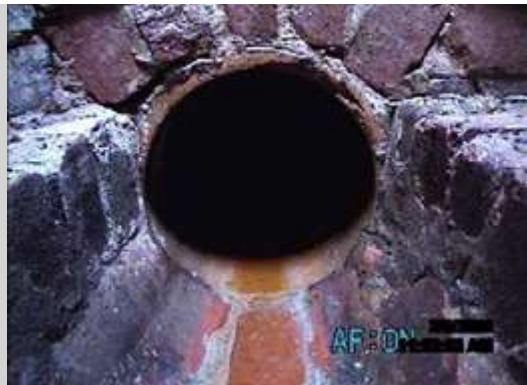
4 O'Clock Inflow

Pipe Height: **8.4** (in.) Rod and Bar (Angled)
Pipe Material: **Clay** ☐ Pipe Lined
Invert Depth: **7.74** (ft.) Flow Characteristics: **None**
Deposits: ☒ None ☐ Mud ☐ Sludge ☐ Debris ☐ Grease
Silt Depth: **0** (in.) Deposits Extent:
Infiltration: **None** Pipe Seal Cond: **Sound**
